DEPARTMENT OF TRANSPORTATION

Contract #: 04-0120F4Cty: SF/ALA Rte: 80 PM: 13.2/13.9File #: 69.28**WELDING INSPECTION REPORT****Resident Engineer:**Pursell, Gary**Address:** 333 Burma Road**City:** Oakland, CA 94607**Report No:** WIR-003901**Date Inspected:** 13-Sep-2008**Project Name:** SAS Superstructure**OSM Arrival Time:** 1400**Prime Contractor:** American Bridge/Fluor Enterprises, a JV**OSM Departure Time:** 2230**Contractor:** Zhenhua Port Machinery Company, Ltd (ZPMC), Changxing Island **Location:** Shanghai, China**CWI Name:** Fu Yu Hong**CWI Present:** Yes No**Inspected CWI report:** Yes No N/A**Rod Oven in Use:** Yes No N/A**Electrode to specification:** Yes No N/A**Weld Procedures Followed:** Yes No N/A**Qualified Welders:** Yes No N/A**Verified Joint Fit-up:** Yes No N/A**Approved Drawings:** Yes No N/A**Approved WPS:** Yes No N/A**Delayed / Cancelled:** Yes No N/A**Bridge No:** 34-0006**Component:** OBG**Summary of Items Observed:**

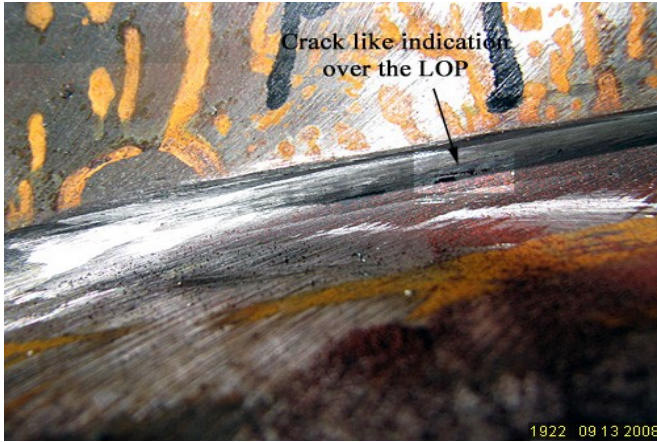
The QA inspector performed random visual verifications after ZPMC ground the U-ribs PJP at areas identified by Caltrans as crack like indications areas over the LOP areas (Second Time repairs). The QA inspector observed 3 crack like indications as observed below photos.
